MAterials solutions for cost Reduction and Extended service life on WIND off-shore facilities

EU H2020 PROJECT

GENERAL PRESENTATION

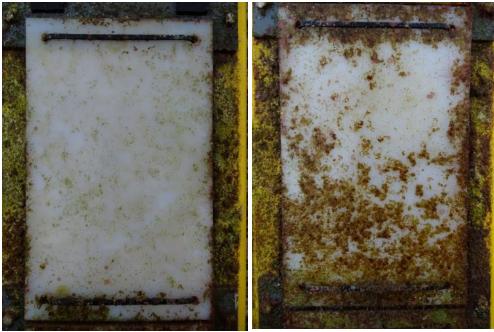
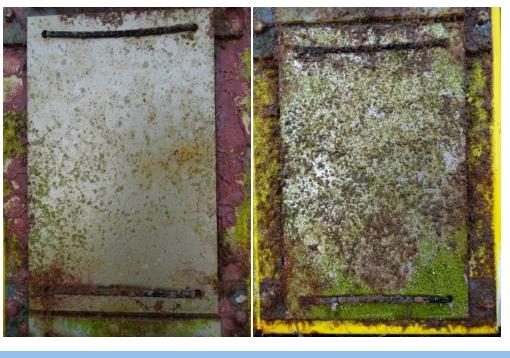
MAREWIND ANTIFOULING SOLUTION SUCCESSFULLY TESTED IN REAL EXPOSURE IMMERSED IN THE SEA

Nylon coated –

non coated

Stainless steel coated -

These experiments have been performed in the facilities of Consorcio Plataforma Oceánica de Canarias (PLOCAN) by EnerOcean according to ASTM3623 regulation in conditions of full immersion during 2 months

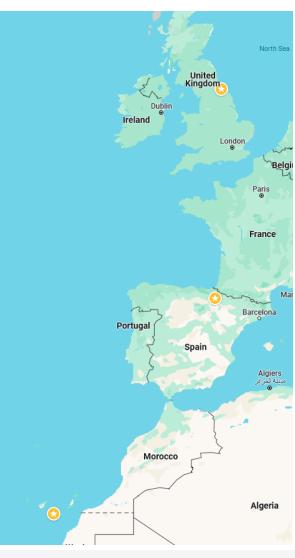
REAL EXPOSURE OVERVIEW for COATINGS

North sea (Teesside)

Atlantic sea (Canary

Northern Spain

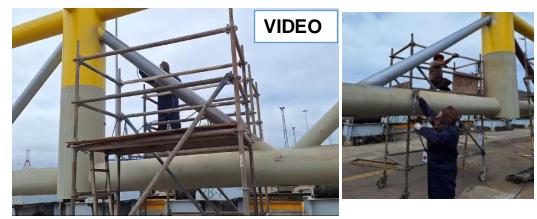
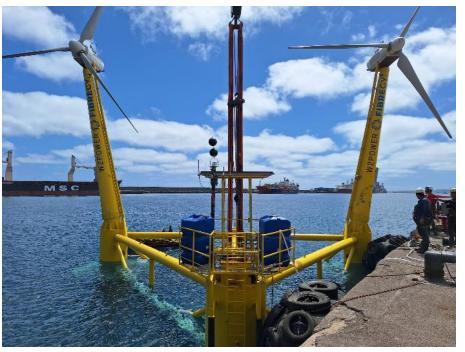
Testing sites: ENEROCEAN -> Wind2Power floating platform

Oblique braces in W2Power platform were coated with the Anticorrosion solution

Canary Islands, South Atlantic Ocean

Submerged exposure Col D

Coupons coated by TECNAN

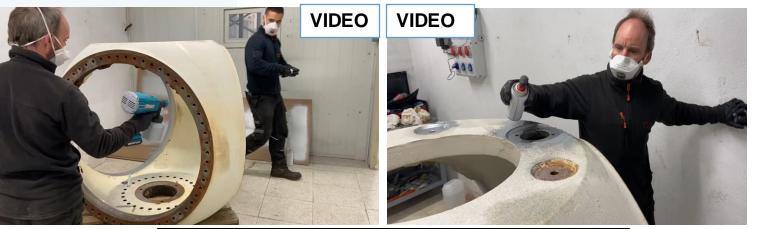
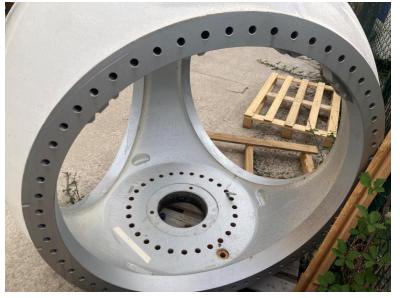
Testing sites: KOSHKIL -> Corrosion repair of real wind turbine elements

Direct application systems: electric spray gun and aerosol

IN MAINTENANCE AREA, DISSASEMBLED PART (ROTOR HUB)

Repair and maintenance operations were carried out in with the new anticorrosion coating

Exposed outdoors in Pamplona Area (North of Spain)

INSIDE WINDMILL, IN SITU APPLICATION, ASSEMBLED PARTS

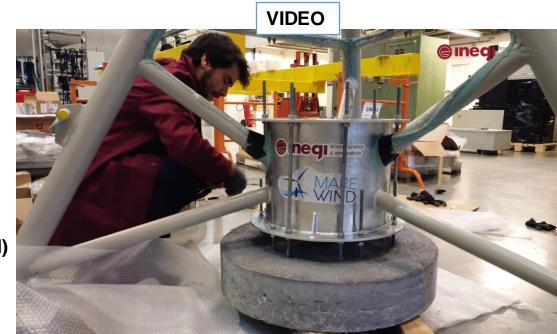
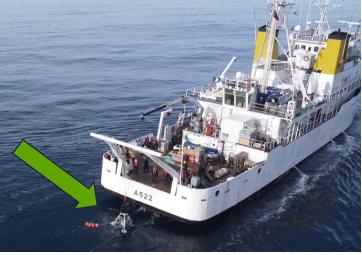
Testing sites: INEGI -> GBS subsea in Sines

Coupons coated with antifouling (TECNAN) in GBS structure (INEGI)

Comparisons including:

- □ Coated (MAREWIND)
- Uncoated
- Commercial references

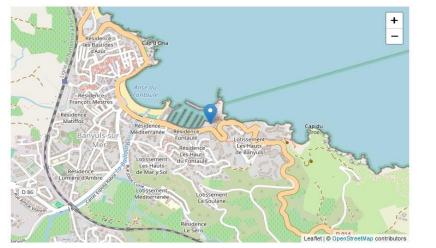
Testing sites: EDF -> Test in Banyuls-sur-Mer

Mediterranean sea, FRANCE

- Banyuls (France) Laboratoire de Biodiversité et Biotechnologies Microbiennes
- Real sea water is used for the essay

Treatment	Substrate	Coupon 1	Coupon 2	Coupon 3	Mean
T1. Transment antifauling (Managuind)	Polycarbonate (PC)	2	2	2	2.0
T1: Transparent antifouling (Marewind)	Inox	2	3 2 2.3 2 2 1.7		
T2: Coloured antifouling (Marewind)	Polycarbonate (PC)	1	2	2	1.7
	Inox	1.5	1.5	1.5	1.5
T3: Coloured higher hydrophobicity antifouling (Marewind)	Polycarbonate (PC)	2.5	2	2.5	2.3
15. Coloured higher hydrophobicity antifodiling (Marewind)	Inox	2.5	2.5	2	2.3
T4: Epoxy primer + antifouling (Marewind)	Polycarbonate (PC)	4	4	4	4.0
14. Epoxy primer + antifouning (Marewind)	Inox	4	4	4	4.0
T5 : Commercial	Polycarbonate (PC)	3	3	3	3.0
15 : Commercial	Inox	4	3	4	3.7
LINE Lintroated (controls)	Polycarbonate (PC)	5	5	5	5.0
UN: Untreated (controls)	Inox	5	5	5	5.0

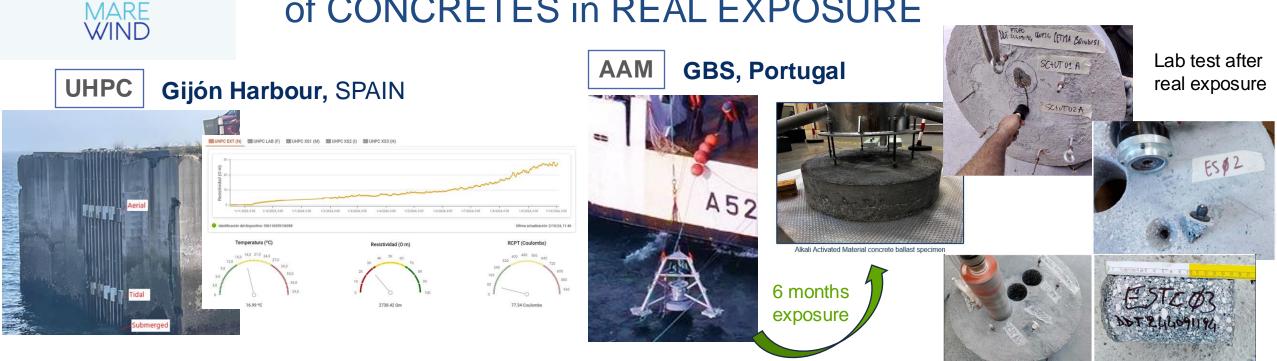
Testing sites: ACCIONA AND CETMA (2/2)-> Validation of CONCRETES in REAL EXPOSURE

AAC: after 6months exposure in the sea, the **mechanical performance did not decrease**. When the specimens were subjected to accelerated ageing cycles, **no weight loss** was observed, indicating that the specimen did not degrade but, contrary to expectations, <u>losses in compressive</u> <u>strength</u> were found.

UHPC corrosion: tests are still on-going and will be left on place for longer ages performance analysis. During these months, monitoring results from real environment, concluded that this solution presents a **more durable** concrete solution and presents <u>3 times lower</u> penetrability to chlorides than the standard solution.

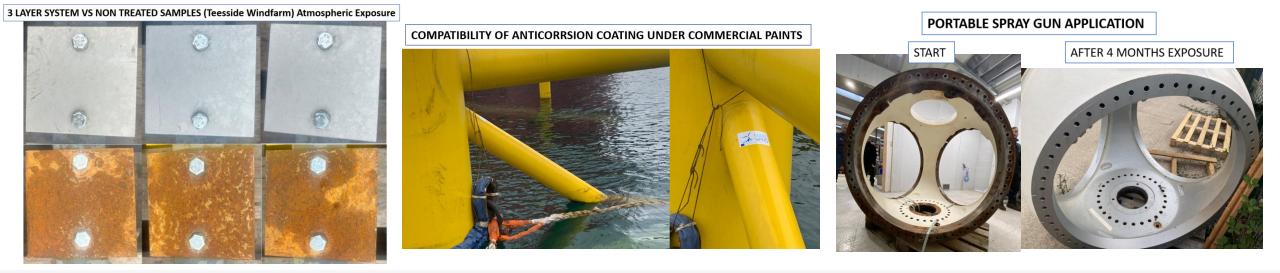
ANTICORROSION COATING:

- Good performance under **real marine exposure** for more than 8 months in different sea locations. Treated parts or coupons coated with the novel low thickness anticorrosion coatings, are not damaged by corrosion.
- The anticorrosion coating shows good **compatibility with other commercial coatings**, for instance with the yellow paint in compliance with current maritime regulations for platforms.
- In the case of **repair and maintenance actions**, the coating demonstrated versatility during application, offering both an aerosol format option as well as other portable spray techniques, which provided good surface coverage with the novel coating.

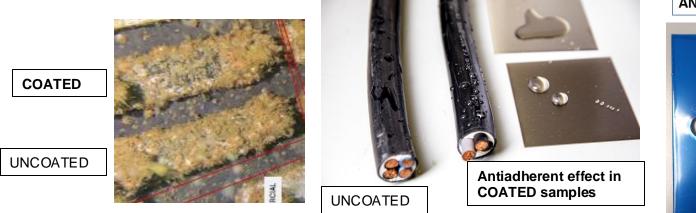
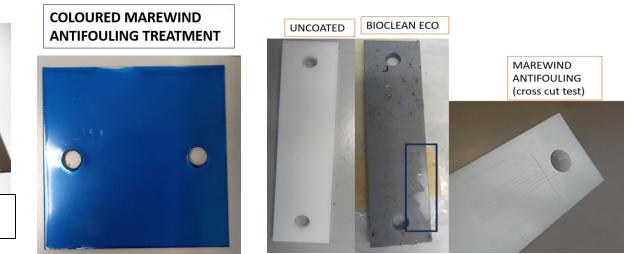
ANTIFOULING COATING:

- Significant delay in biofouling growth in treated samples both in metal and polymeric material compared to uncoated.
- The one-layer low thickness coating from MAREWIND has the advantage over commercial solutions of providing good adhesion to various substrates, whether metallic or polymeric.
- The anti-adherent coating, offers versatility for incorporating **colour** in case is needed by potential end users.
- This coating shows good compatibility for application over commercial epoxy-based primers, according to the latest tests conducted in real environments.

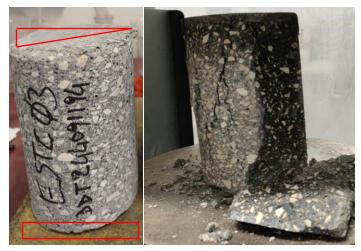
After 6 months of immersion real condition exposure no reduction in compressive strength was observed

After a further 200 freeze-thaw cycles in a climate chamber, No loss in weight was observed, indicating that the structure of the samples was not compromised

UHPC: presents 33% reduction in cement used compared to standard leading to a more sustainable solution than the commercially available solution. Durability tests according to NT-492 showed after a year of exposure negligible corrosion rate (kΩ·cm) and extremely-high chloride penetration resistance (0.008 m²/s). Freeze and thaw resistance test reflected high durability performance at 200 cycles.
